Kia Niro
Standard Safety Equipment

2022 ★★★★★

SPECIFICATION

Tested Model	Kia Niro
Body Type	- 5 door SUV
Year Of Publication	2022
Kerb Weight	1682kg
VIN From Which Rating Applies	- all Niros
Class	Small Off-Road

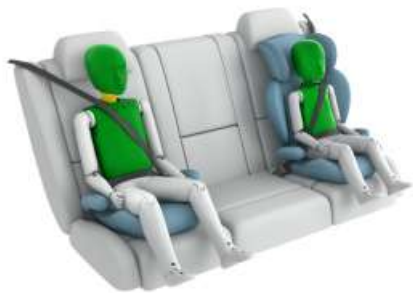
Frontal Impact

15.9 Pts

In the frontal offset test, protection of the 6 year dummy was good for all critical body areas and that of the 10 year dummy was good apart from adequate protection of the neck. In the side barrier test, dummy readings of acceleration in the head of the 10 year dummy revealed weak protection of that body region, probably related to bottoming-out of the airbag, but protection of all other critical areas was good for both the 6 and 10 year dummies. The front passenger airbag can be disabled to allow a rearward-facing child restraint to be used in that seating position. Clear information is provided to the driver regarding the status of the airbag and the system was rewarded. All of the restraint types for which the Niro is designed could be properly installed and accommodated.

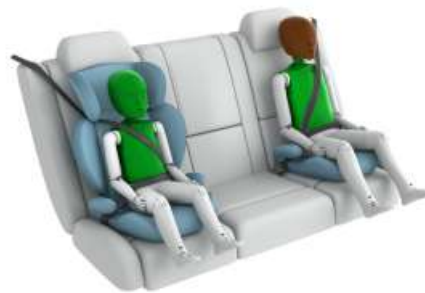
Lateral Impact

6.3 Pts

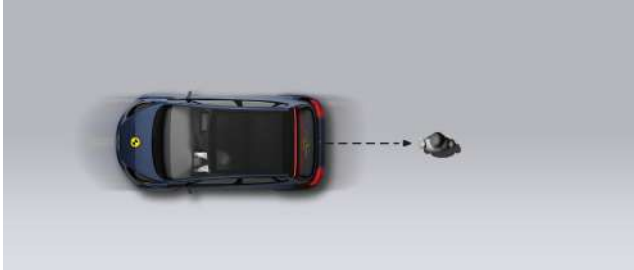
Vehicle reversing into standing pedestrian

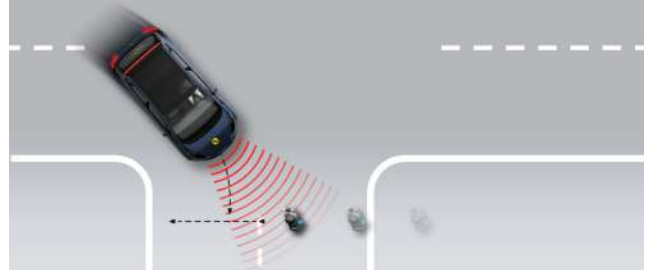
Pedestrian crossing a road into which a car is turning

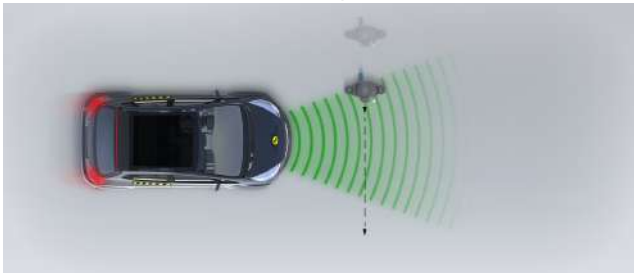
Adult crossing the road

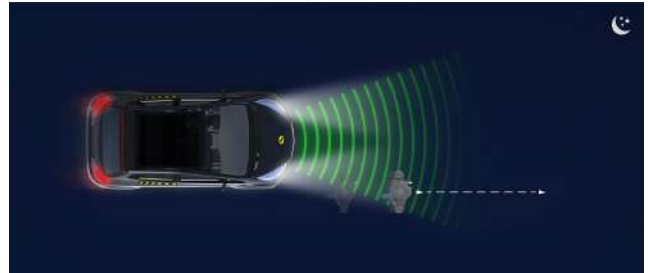
Adult along the roadside

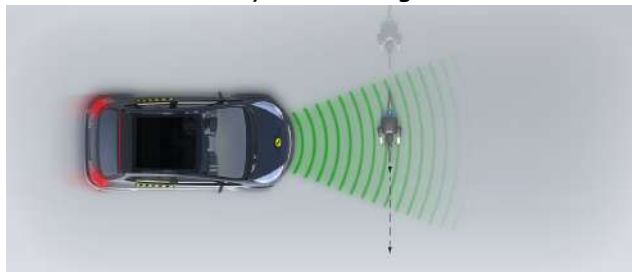
Cyclist crossing

The protection provided by the bonnet to the head of a struck pedestrian was predominantly good or adequate, with poor results recorded at the base of the windscreen and on the stiff windscreen pillars. The bumper offered good protection to pedestrians' legs and protection of the pelvis region was also good at all test locations. The autonomous emergency braking (AEB) system of the Niro can respond to vulnerable road users, as well as to other vehicles. The system performed adequately in tests of its response to pedestrians and well when tested using targets representing cyclists, with collisions avoided or mitigated in most scenarios.

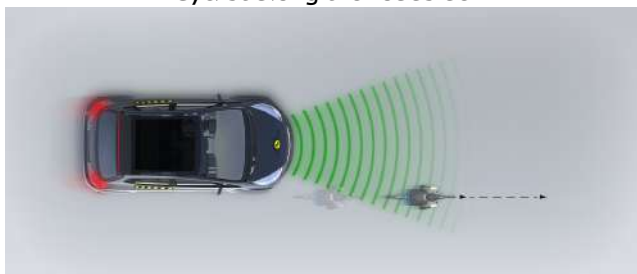
Cyclist along the roadside

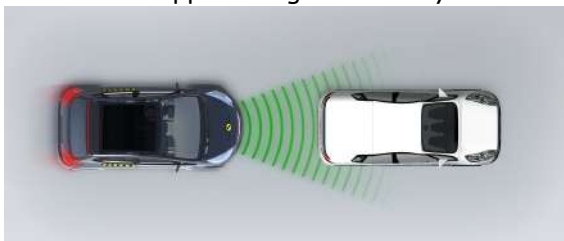
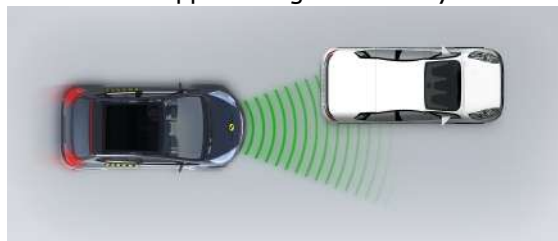
Approaching a stationary car

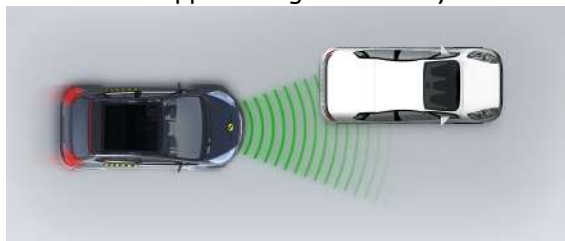
Approaching a stationary car
